# HISTORIC PROPERTY INVENTORY FORM

Field Site No. 3709-A OAHP No. \_\_\_\_\_ Date Recorded 20 Oct 1994  
Site Name Historic Fire Station Revised 29 May 1998  
Common \_\_\_\_\_  
Field Recorder K.A. Simmons, M.E. Crist, J.K. Keating  
Owner's Name U.S. Department of Energy, Richland Operations Office  
Address P.O. Box 550  
City/State/Zip Code Richland, WA 99352

Address Building 3709-A, 300 Area  
City/Town/County/Zip Code Richland/Benton County/99352  
Twp 10 N Range 28 E Section 11 1/4 Section NW 1/4 1/4 Sec \_\_\_\_\_  
Tax No./Parcel No. \_\_\_\_\_ Acreage \_\_\_\_\_  
Quadrangle or map name Richland, Washington Quad. - 7.5 min series 1992  
UTM References Zone 11 Easting 324460 Northing 5137860  
Plat/Block/Lot \_\_\_\_\_  
Supplemental Map(s) \_\_\_\_\_

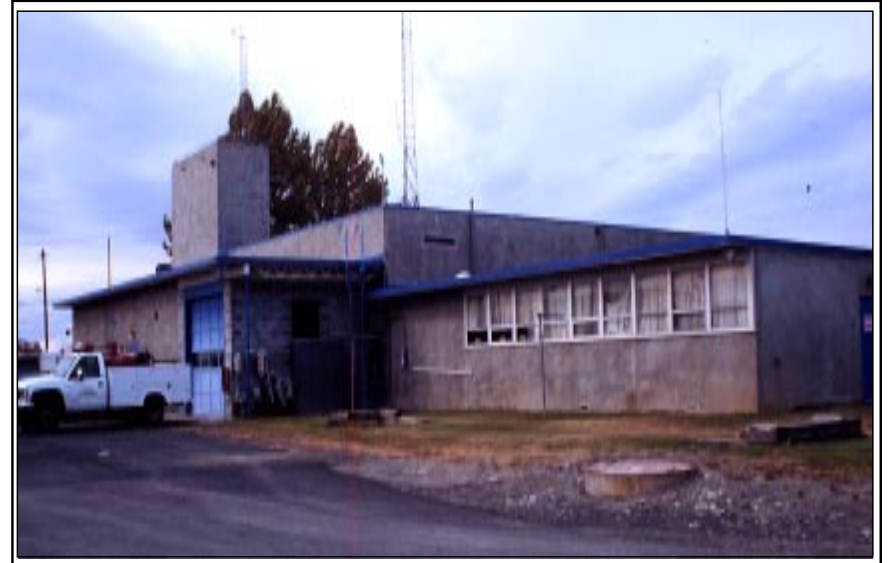
Photo at right; Roll 181, Frame 4  
view of south facade

The north side of the building is the main entrance. On the central portion of this elevation are three garage doors, sheltered by an overhang, that serve the fire trucks. West of this is a single entry door leading to the central interior garage portion of the station. A western wing extends north, and on its northern end are four vertical, metal-framed windows. On the west elevation is the hose tower, two windows and a single door. North of the tower the facade is recessed and is lined with a long row of windows beneath an overhang. The south wall contains another garage door with concrete block supporting walls. The north end contains a row of windows from the kitchen and living areas. Inside the building is a open garage area, offices on the west wing, and kitchen and living areas on the east wing. The southern area appears to be used for storage and HVAC equipment.

The 3709-A Fire Station has an irregular plan, and different sections of the building have varying roof heights. The roof over the main building portion is built-up over metal decking and lightweight concrete. The roofing on the hose tower is built-up roofing over cast-in-place reinforced concrete. The building measures 8,350 gross square feet. This building has undergone no major changes to its physical appearance.
